ANNUAL REPORT FOR 2007

**UT to Cold Water Creek Mitigation Site
Cabarrus County
TIP No. R-2533B (Site 23)**

Prepared By:
Natural Environment Unit & Roadside Environmental Unit
North Carolina Department of Transportation
May 2007

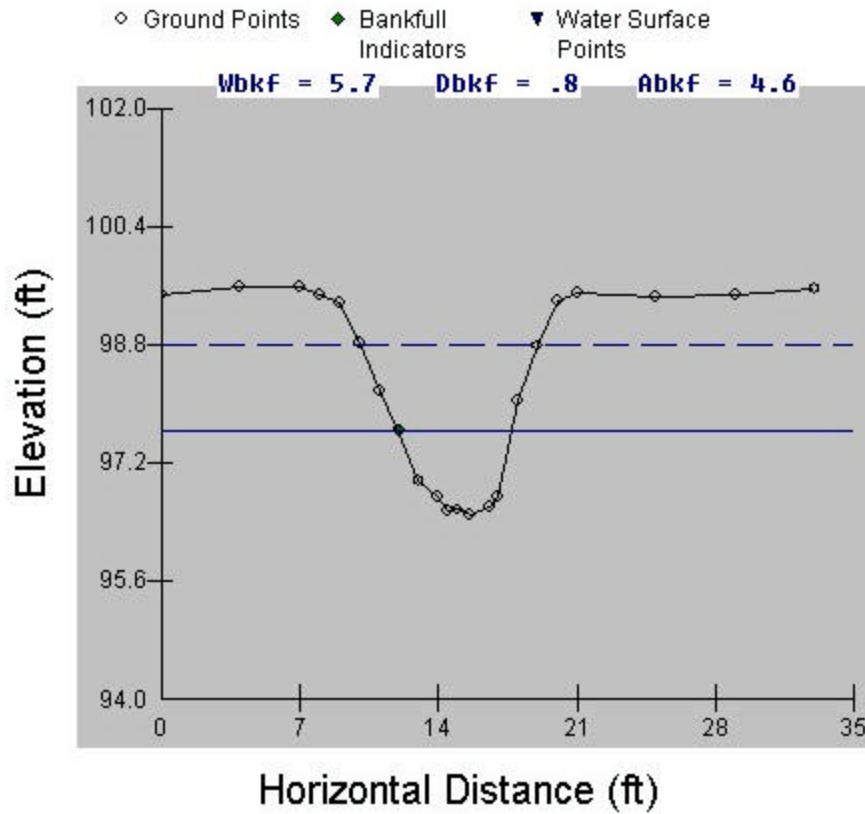
Cross Section #1 Riffle

Based on comparisons of design cross section data and Year 2007 monitoring data, all of the cross sections appear stable with little or no active bank erosion. Graphs of the cross sections are presented in Appendix A. Future survey data will vary depending on actual location of rod placement and alignment, however, this information should remain similar in appearance. Pebble counts were not required per the permit conditions and therefore were not completed.

Site #23: Cross-Section #1 (Riffle) Abbreviated Morphological Summary

2007	2008	2009	2010	2011
Bankfull Cross Sectional Area (ft ²)	4.6				
Maximum Bankfull Depth (ft)	1.2				
Width of the Floodprone Area (ft)	9.0				
Bankfull Mean Depth (ft)	0.8				
Width/Depth Ratio	7.0				
Entrenchment Ratio	1.6				
Bankfull Width (ft)	5.7

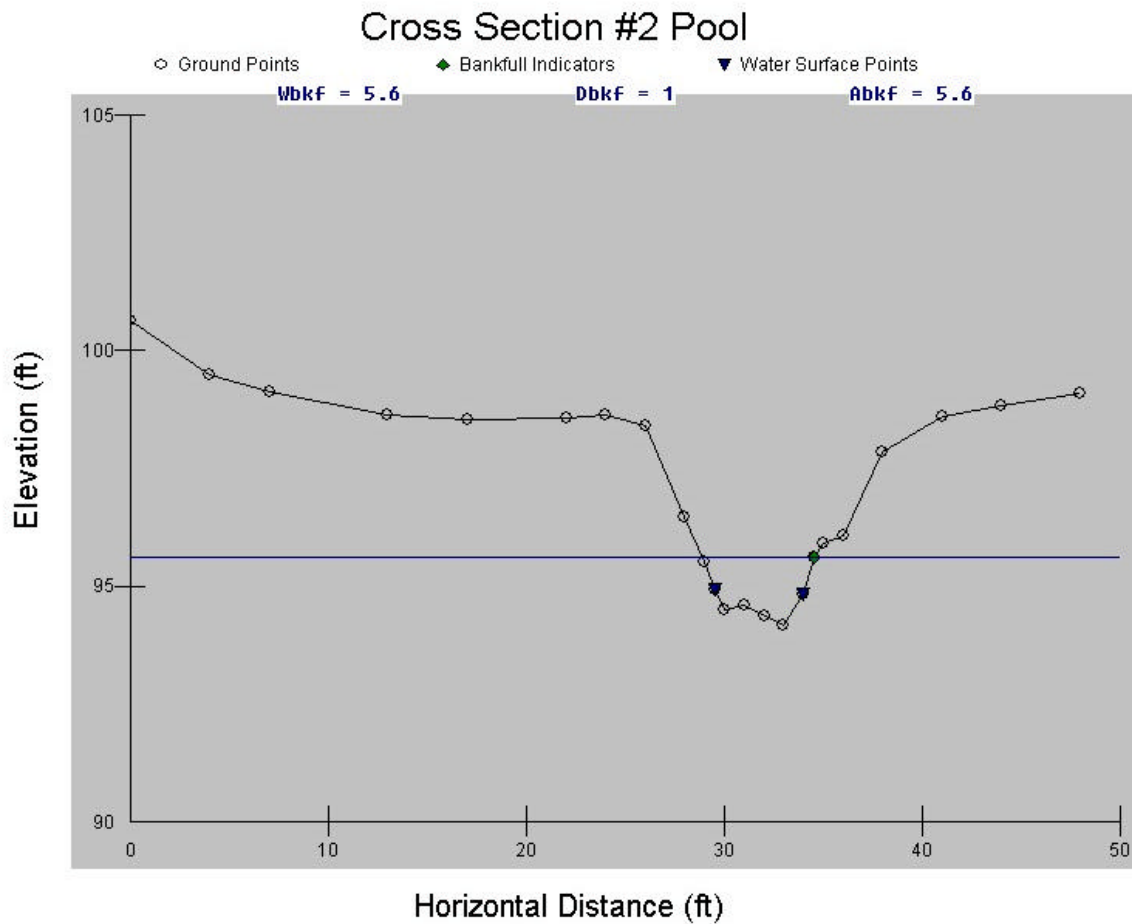
Site #23: Cross-Section #2 (Pool) Abbreviated Morphological Summary*

2007	2008	2009	2010	2011
Bankfull Cross Sectional Area (ft²)	7.83				
Maximum Bankfull Depth (ft)	1.39				
Bankfull Mean Depth (ft)	0.86				
Bankfull Width (ft)	9.13
